INVENTORY FORM FOR STATE HISTORIC SITES SURVEY

Dixie

West side Maryland Route 8

Mattapeake☒ VICINITY OF

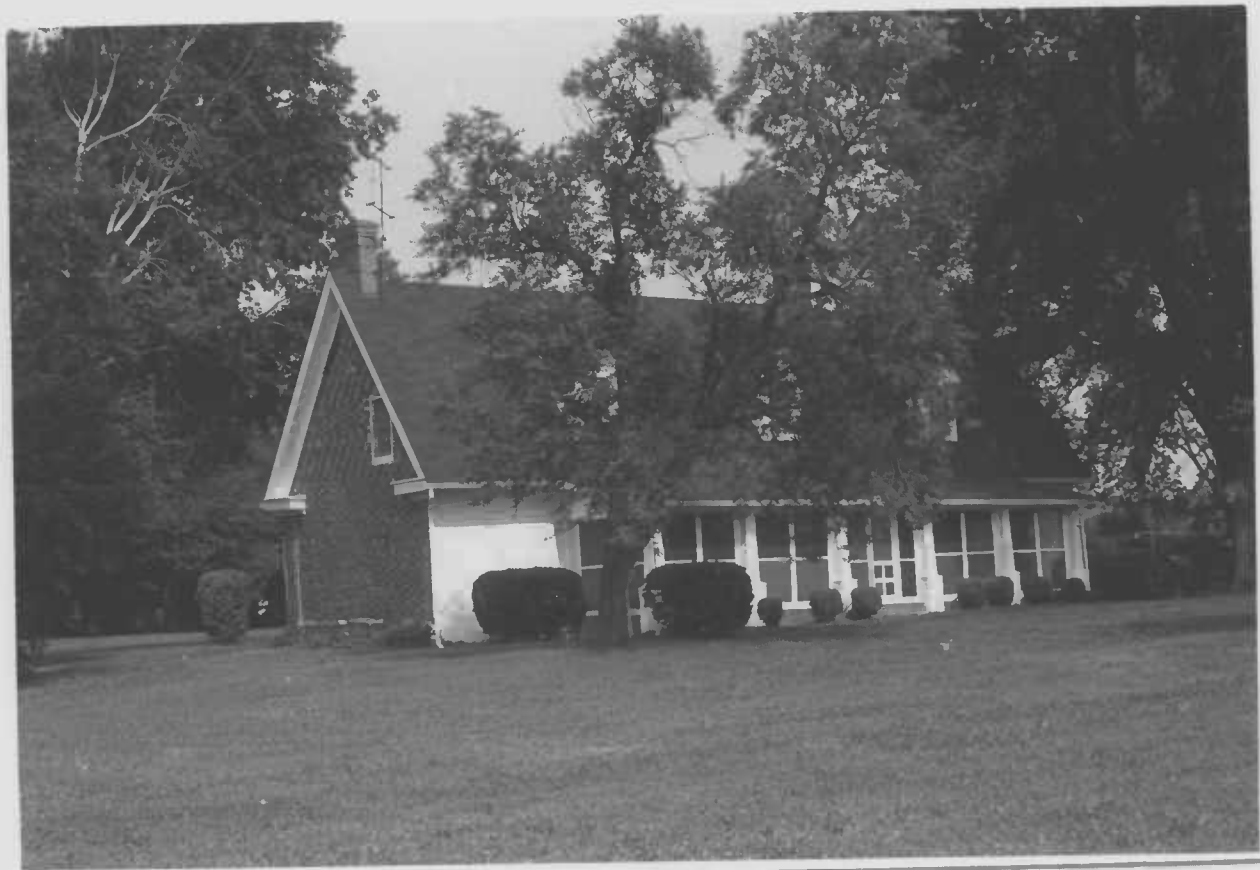
QA-202

West facade from northwest

The rear facade faces west to the Chesapeake Bay. The door is located in the center bay, flanked by a single 9/6 window to the north and double doors to the south. There are two 6/6 pitched roof dormers on the roof. The brickwork on this facade is laid in five-course bond above a plain water table and a common bond foundation. Major repairs appear to have been undertaken to the south of the door, and the door opening has been reduced approximately nine inches in width. The eaves and dormers have been rebuilt and covered with aluminum siding; the roof is asphalt shingle.

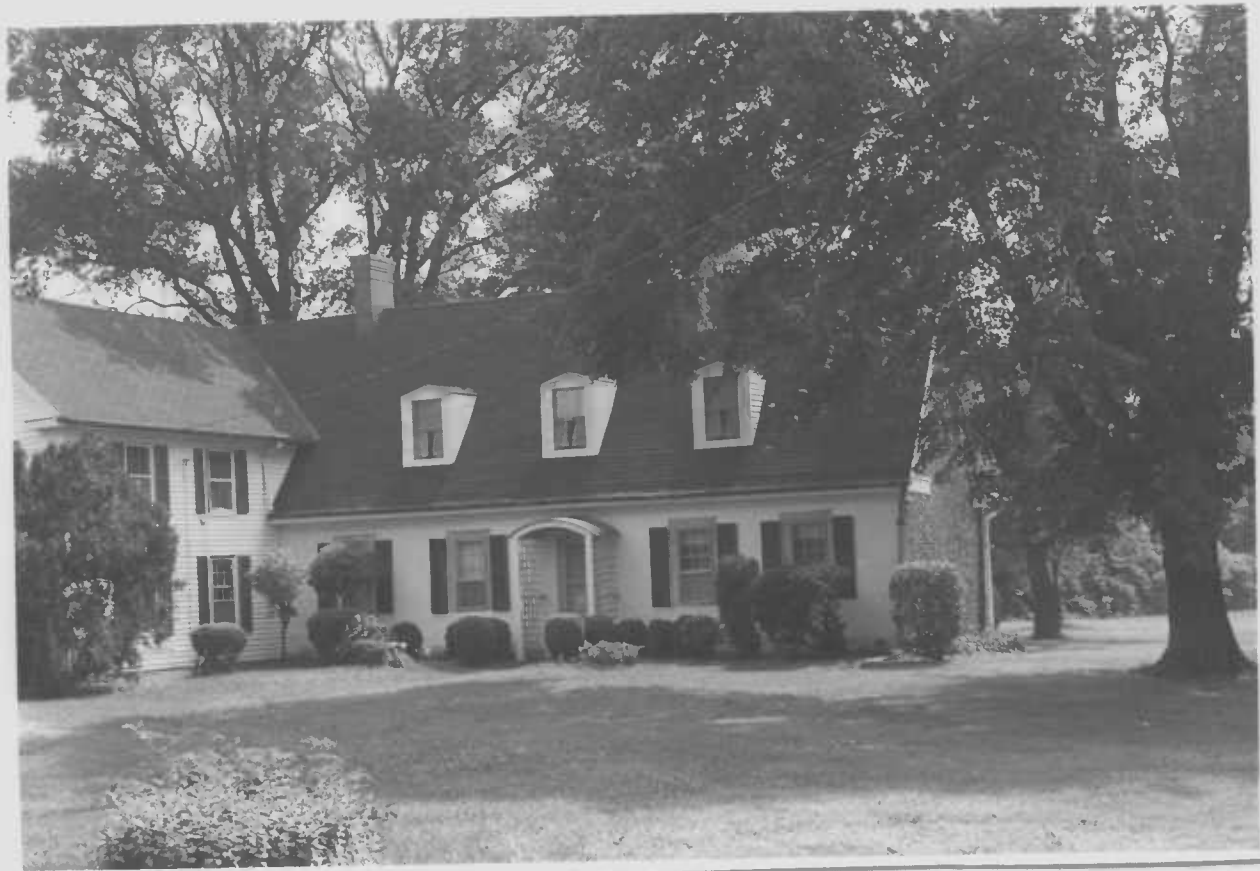
QA-202

Dixie
Mattapeake vicinity
Orlando Ridout V 1981
East facade

The principal facade faces due east toward Route 8. The door is in the center bay flanked by two 9/6 windows on each side. There are three pitched roof 6/6 dormer windows on the second floor. The brickwork on this facade is heavily whitewashed and difficult to analyze. Large portions of the wall appear to be rebuilt or repaired. One relatively undisturbed section of Flemish bond is visible between the two north windows. The foundation appears to be laid in common bond with a plain water table. The brick facade extends out approximately four inches beyond the north gable wall, and from here it is clear that the facade is
